# Manhole Inspection Summary

Manhole # S43E\_\_032MH

Insp Date: **4/23/08 8:33 AM**

**Location** Address: **Broadway**

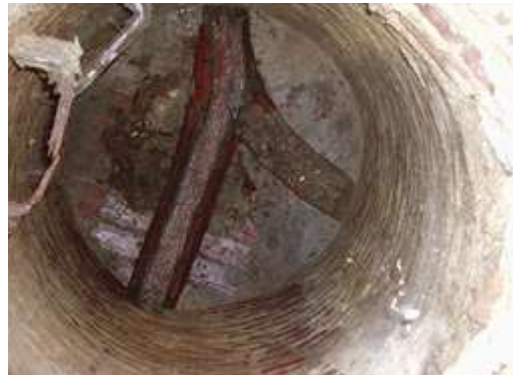
Top View

No connection at 4 O'Clock.

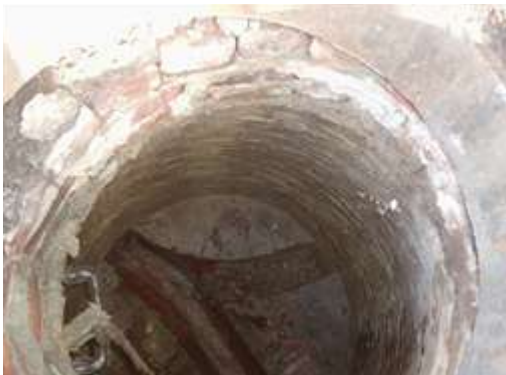
Defect 1

Condition: ☐ Sound ☐ Cracked ☐ Root Intrusion ☒ **Loose Brick** ☒ **Deteriorated**

Deterioration

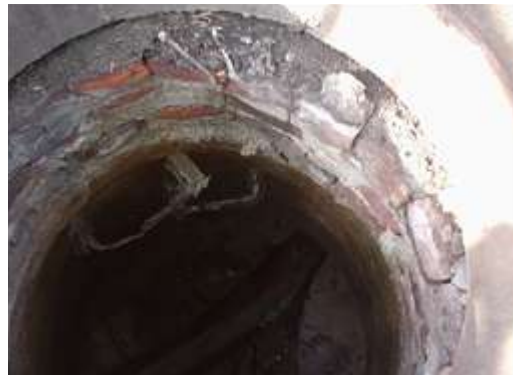
Defect 2

Infiltration: ☐ None ☒ **Joint** ☐ Cracks ☒ **Mortar** ☐ Roots ☐ Wall

Loose Bricks

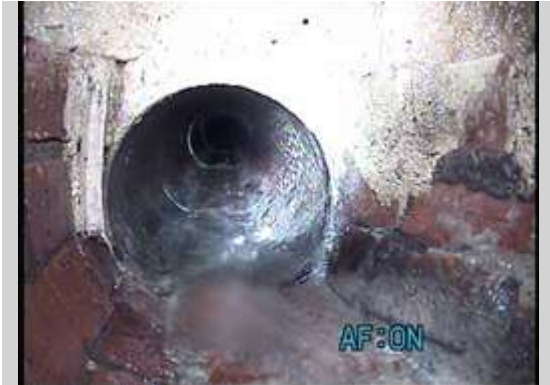
12 O'Clock Outflow

8 in. Circular Gravity Sewer  
Pipe Out @ 12 O'Clock

Pipe Height: **8.4** (in.) Rod and Bar (Angled)  
Pipe Material: **Clay** ☐ Pipe Lined  
Invert Depth: **8.90** (ft.) Flow Characteristics: **Fast**  
Deposits: ☒ None ☐ Mud ☐ Sludge ☐ Debris ☐ Grease  
Silt Depth: (in.) Deposits Extent:  
Infiltration: **None** Pipe Seal Cond: **Sound**

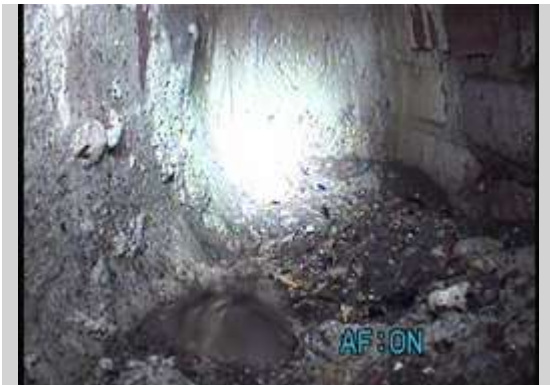
4 O'Clock Inflow

Pipe In @ 4 O'Clock

Pipe Height: (in.) Rod and Bar (Angled)  
Pipe Material: **Clay** ☐ Pipe Lined  
Invert Depth: (ft.) Flow Characteristics: **None**  
Deposits: ☒ None ☐ Mud ☐ Sludge ☐ Debris ☐ Grease  
Silt Depth: (in.) Deposits Extent:  
Infiltration: **None** Pipe Seal Cond: **Sound**

Connects To: **Stub connection / abandoned**

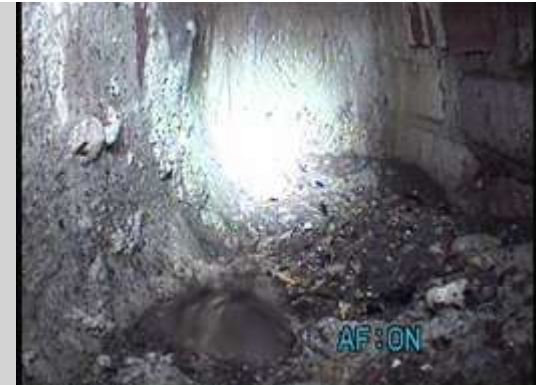
4 O'Clock Inflow

Pipe In @ 4 O'Clock

Connects To: **Stub connection / abandoned**

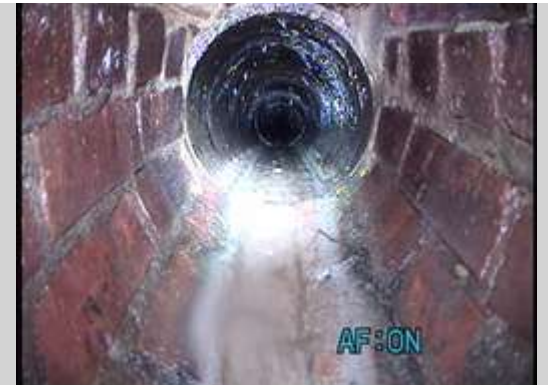
7 O'Clock Inflow

Pipe In @ 7 O'Clock

Pipe Height: **8.4** (in.) Rod and Bar (Angled)

Invert Depth: **8.30** (ft.) Flow Characteristics: **Fast**
